# **Pentium<sup>®</sup> II Processor Specification Update**

Release Date: June 1998

Order Number: 243337-015

The Pentium<sup>®</sup> II processor may contain design defects or errors known as errata which may cause the product to deviate from published specifications. Current characterized errata are documented in this Specification Update.

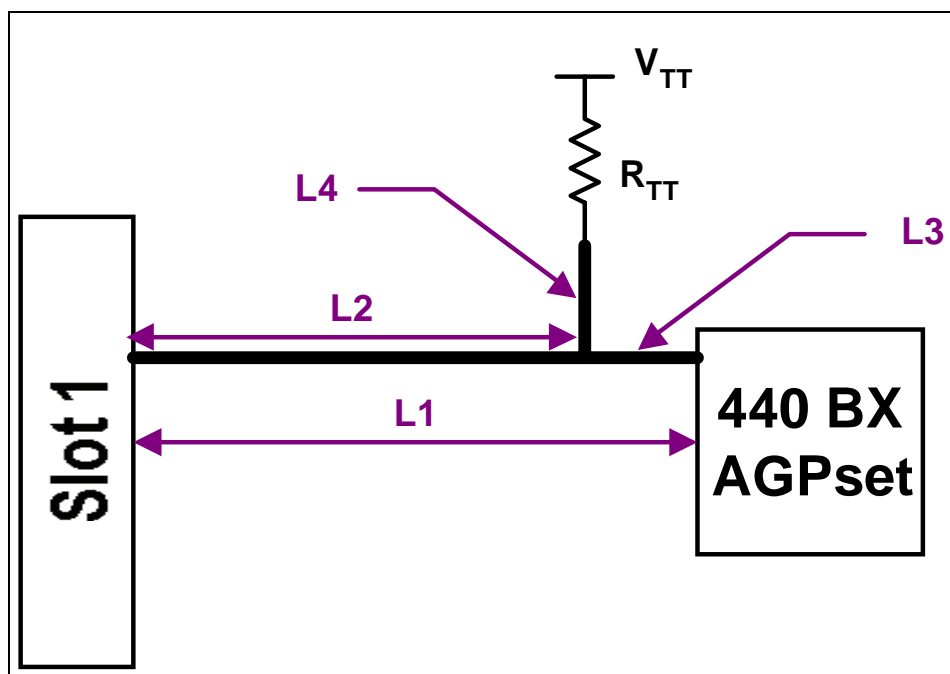
Figure 1. UP Dual Ended Termination (DET)

For UP-DET topologies (see Figure 1), the trace length  $L1$  must be between 1.5" to 4.5" while using a  $56\Omega$  termination resistor.

**WORKAROUND:** If the chipset and third party agents used with the Pentium II processor do not optimize their arbitration latency as described above, no action is required. For the 66 MHz Pentium II processor, no action is required. If agents that have implemented this optimization, by following the *100 MHz GTL+ Layout Guidelines for the Pentium® II Processor and Intel 440BX AGPset* for UP-SET (single-ended termination) and DP with both processors installed, no action is required. The following two cases are additional guidelines for UP-DET (dual-ended termination) and DP-DET with only one processor populated.

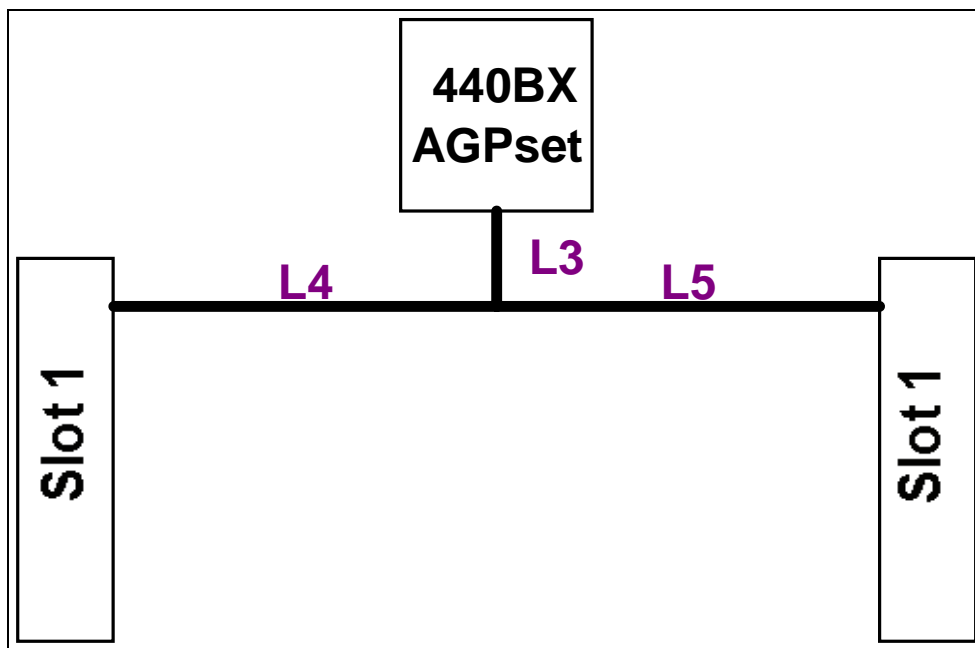
Figure 2. DP Dual Ended Termination (DET)

For DP topologies (see Figure 2) installed with a processor and a termination card,  $L4 + L3$  or  $L5 + L3$  must be less than or equal to 4.5". Additionally, for DP platforms with one processor installed, the termination card should be placed in the longer leg.

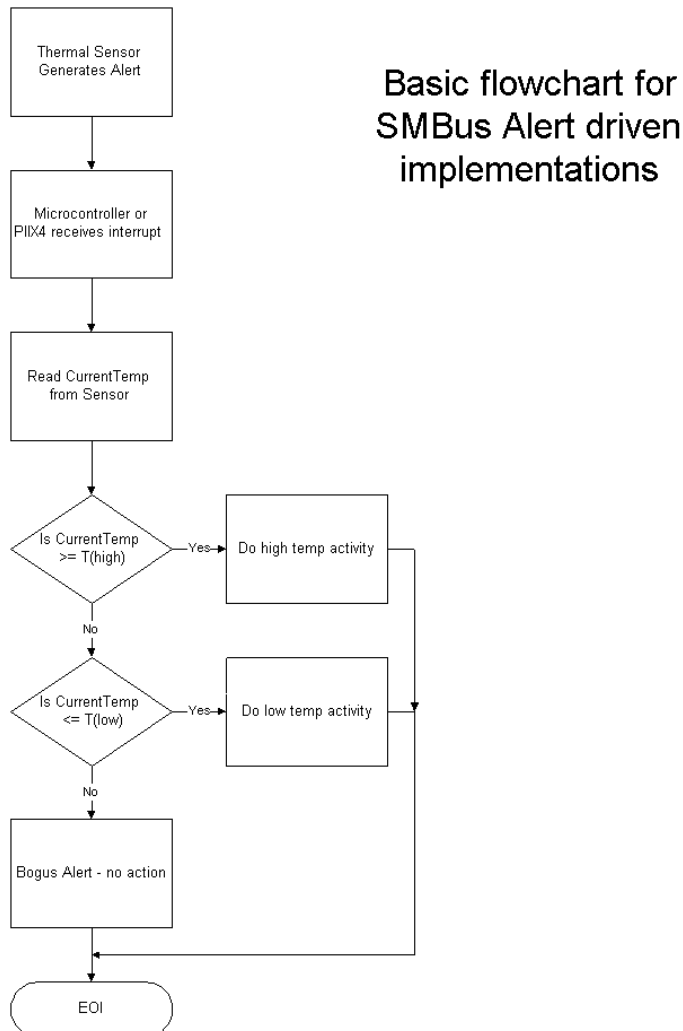
**Figure 5. Workaround Flowchart: SMBALERT#-Driven System**

Under the conditions described below, the thermal sensor incorrectly generates the SMBALERT# interrupt. **All** of the following conditions must be met to trigger a false interrupt:

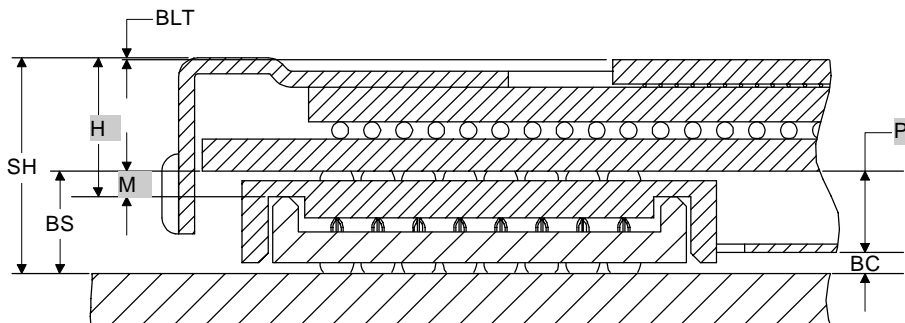
**Figure 5.6 Cross Sectional View With Vertical Dimensions**

**13. Mislabeled Vertical Dimension Parameters**

Figure 5.6 in the *Mobile Pentium® II Processor at 233 MHz and 266 MHz* datasheet should be replaced by the following figure:
